REPORT  
ON  
GROOM MINE MILL BUILDING

Richard A. Ortiz, IAAI-CFI

June 14, 2016

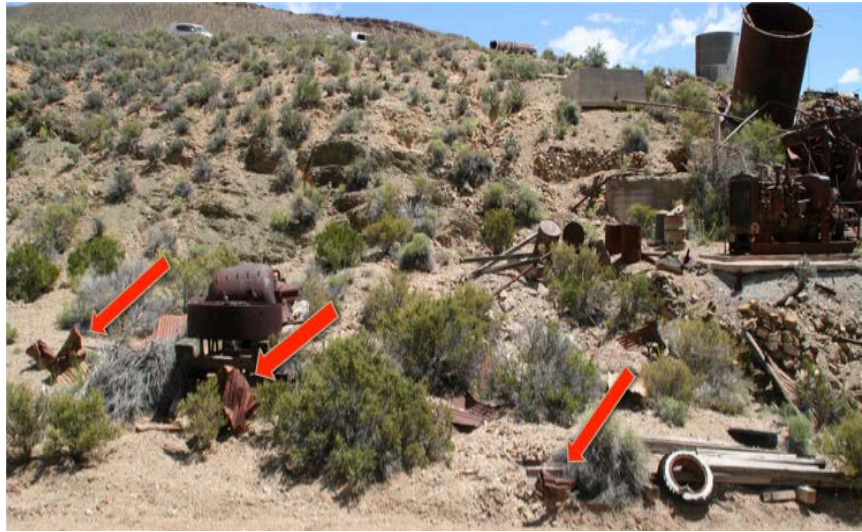
Figure 1. Corrugated metal roof/wall panels exhibiting low-order explosive damage. These panels are located to the north of the Mill Building and are approximately 50-70' from the building.

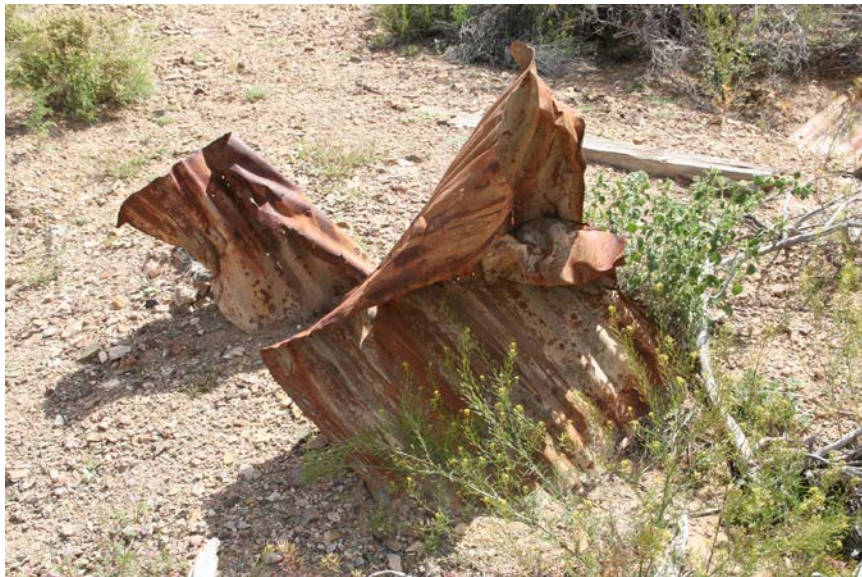
Figure 2. Roof/wall panel exhibiting effects of low-order explosive damage. This panel is located north and approximately 80' from the Mill Building.

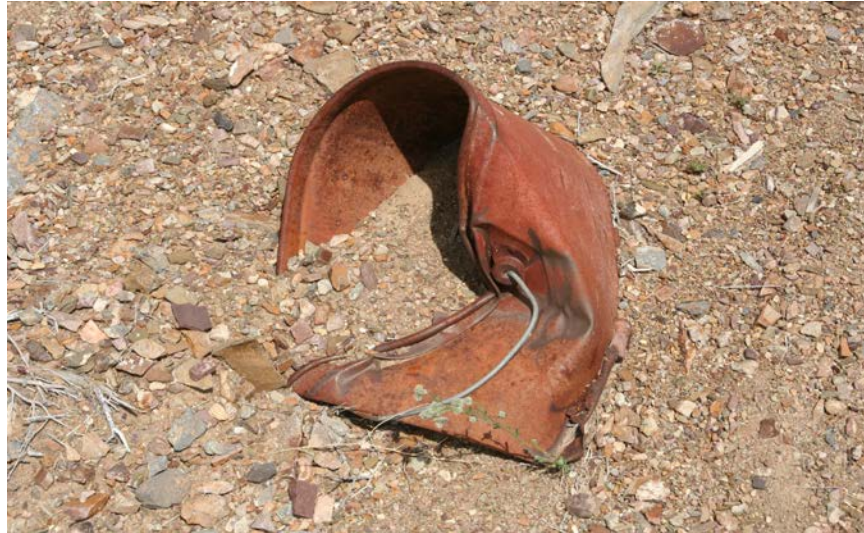
Figure 3. A metal pail exhibiting effects of low-order explosive damage. This pail is located south and approximately 130' from the building.

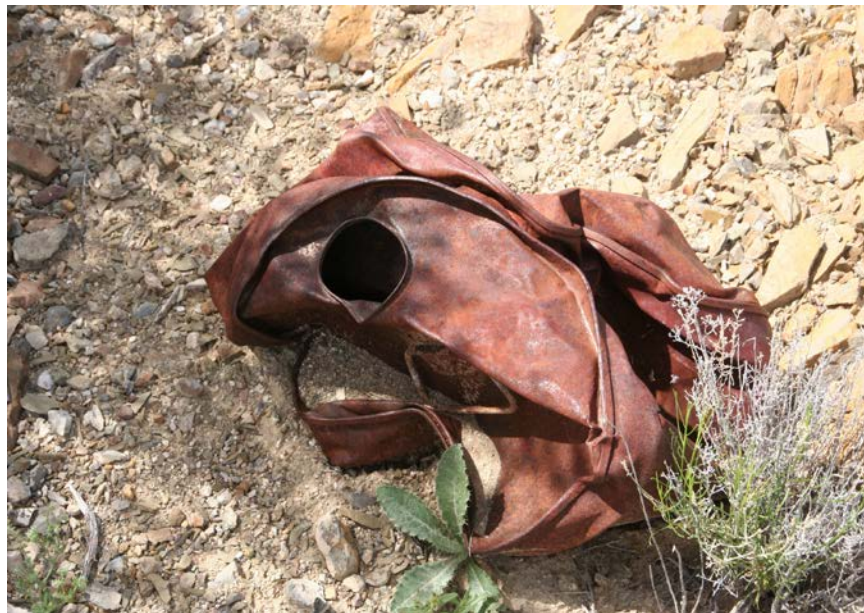
Figure 4. A metal can exhibiting effects of low-order explosive damage. This can is located south and approximately 100' from the Mill Building.

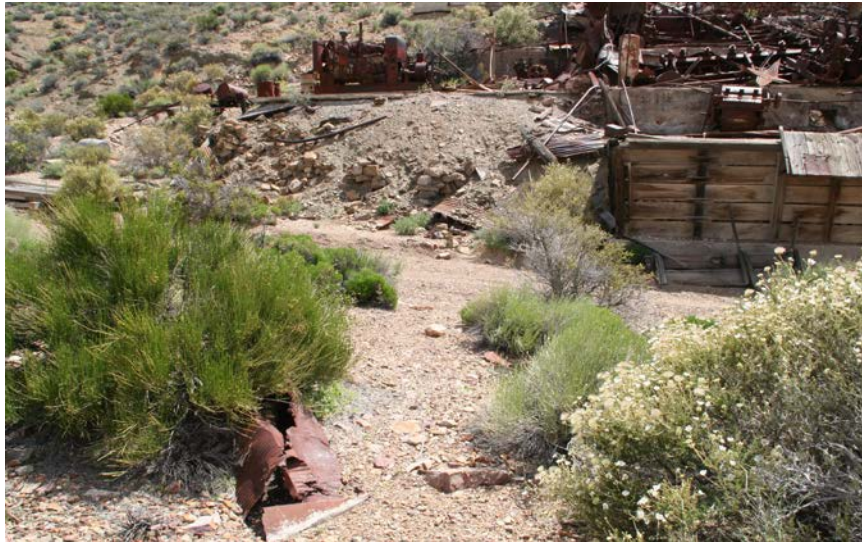
Figure 5. A roof/wall panel exhibiting effects of low-order explosive damage. This panel is located due west and approximately 90' from the Mill Building.

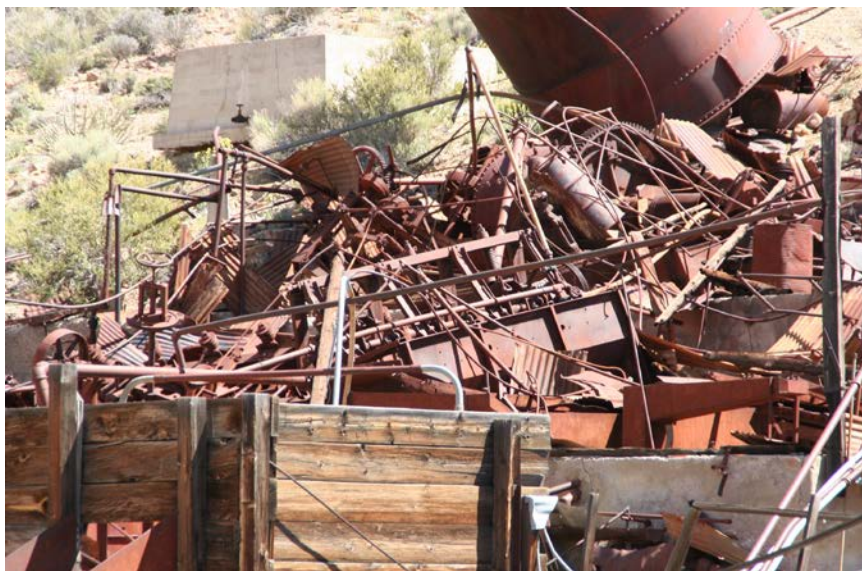
Figure 6. Damaged piping and conduit.

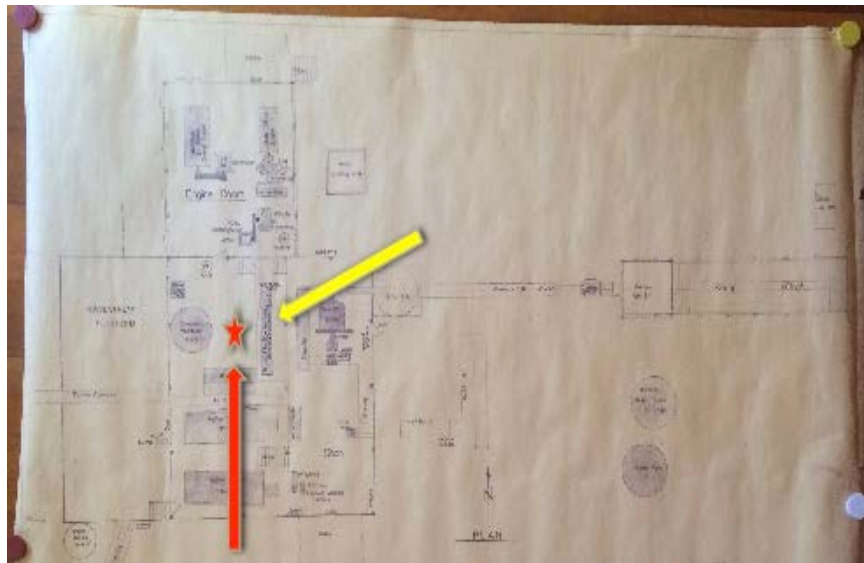
Some of the machinery and equipment located on the inside of the Mill Building was displaced from their original locations to varying degrees. The degree of dislocation was greatest starting from the flotation machine near the northeast corner of the lower tier of the building and lessened as distance increased from that point moving outward. As I examined the flotation machine I discovered that immediately adjacent to it to the east was a pile of roof/wall panels lying on an elevated concrete terrace. Through my analysis I discovered that the flotation machine had originally been mounted on that elevated concrete terrace. Evidence indicates that the flotation machine was bolted to heavy wood skids, which were in turn bolted to the concrete floor of the terrace. The flotation machine was dislocated to the greatest degree of all the machines in the Mill Building. See figure 7-10.

Figure 7. Yellow arrow indicates pre-destruction location of the flotation machine. Red arrow and red star indicate position after dislocation. [Original Mill Building blueprints]. The flotation machine settled in a diagonal aspect on the main floor of the lower tier of the Mill Building with the south end displaced approximately 3 feet to the west and the north end displaced approximately 5 feet to the west.

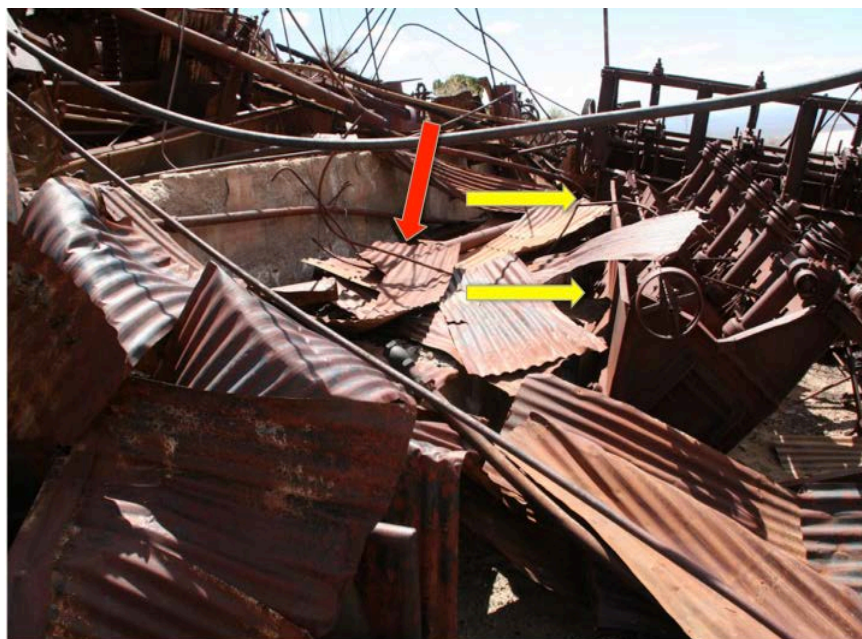
Figure 8. Red arrow points to an elevated concrete terrace covered by roof/wall panels approximately 3' off the main milling floor. Yellow arrows represent direction of travel, as flotation machine was dislocated from its normal location.

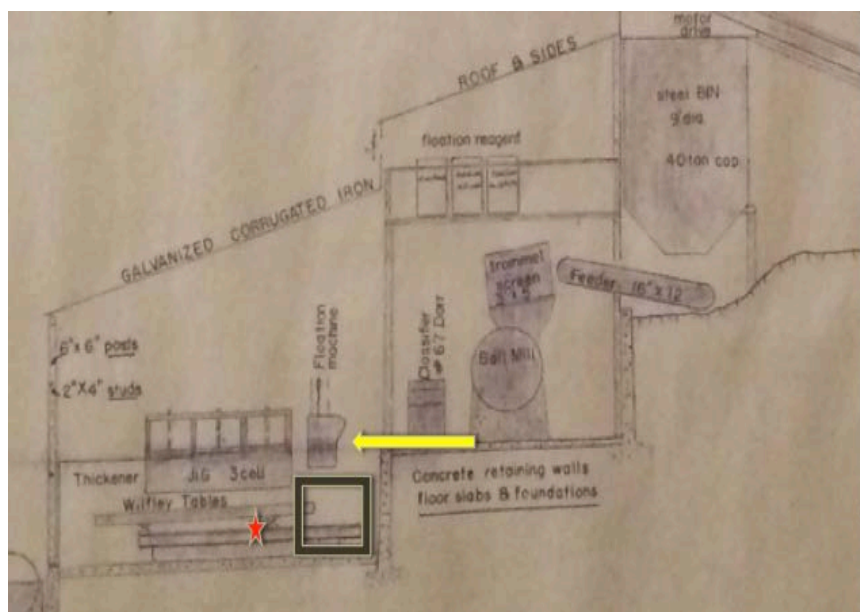
Figure 9. Black box represents the 3' high concrete terrace where the flotation Machine was mounted. Yellow arrow represents direction of dislocation of the flotation machine. The red star represents post-incident resting place of flotation machine. [Approximation].

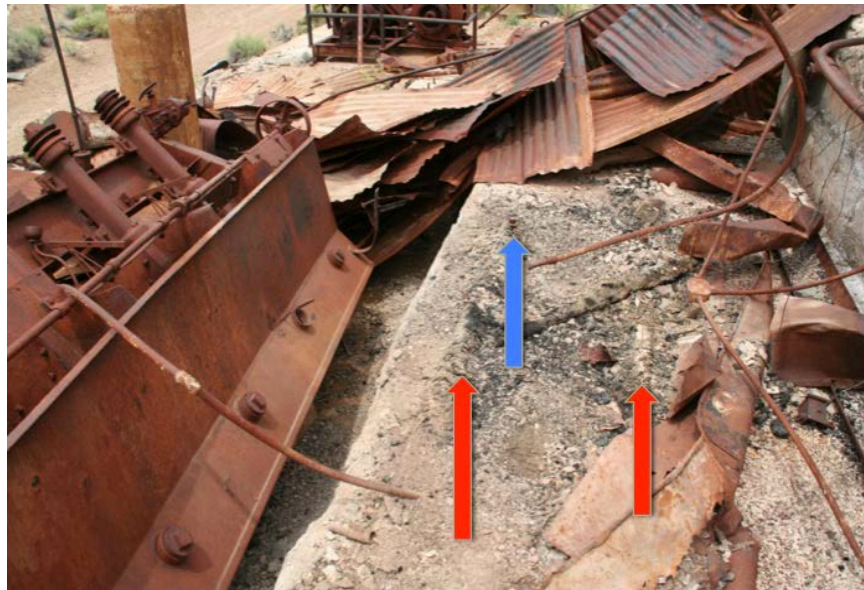
Figure 10. Roof/wall panels removed; shows the exposed elevated concrete terrace the flotation machine was originally mounted on. The red arrows indicate the location of the fire-damaged remains of heavy timber skids the machine was mounted on. The blue arrow reveals one concrete lag bolt used to secure the skids to the concrete floor.

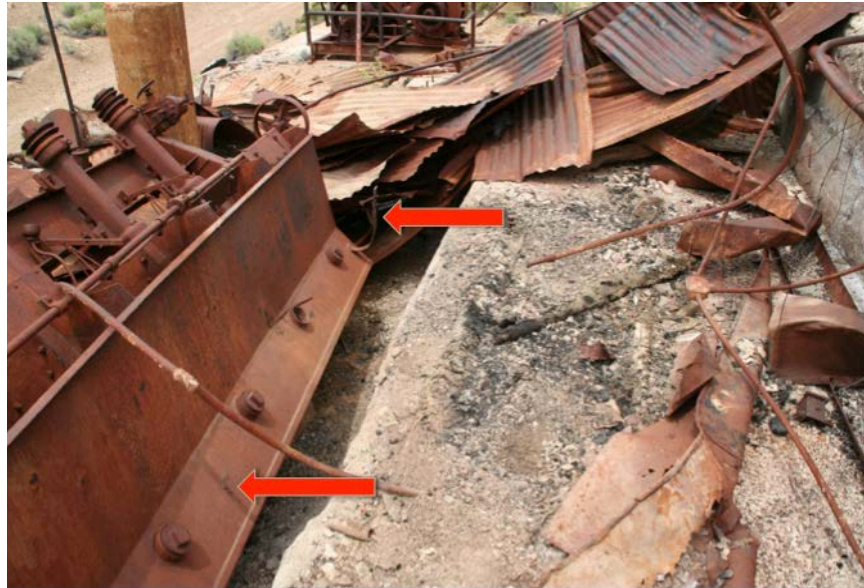
On the east side of the flotation machine and toward the bottom are/were three metal straps that secured the flotation machine to the heavy timber skids it was resting on. Two were broken off from where they were welded to the side of the flotation machine. One remained attached but damaged. The one remaining mounting strap still had one of the long, large diameter wood lag bolts used to secure the straps to the heavy timber skids nearest the concrete barrier wall on the east side of the flotation machine terrace (Figure 11-14).

Figure 11. Top red arrows indicate one remaining strap and large wood lag bolt. Bottom red arrow indicates location of middle strap, which was torn off during dislocation of the flotation machine.

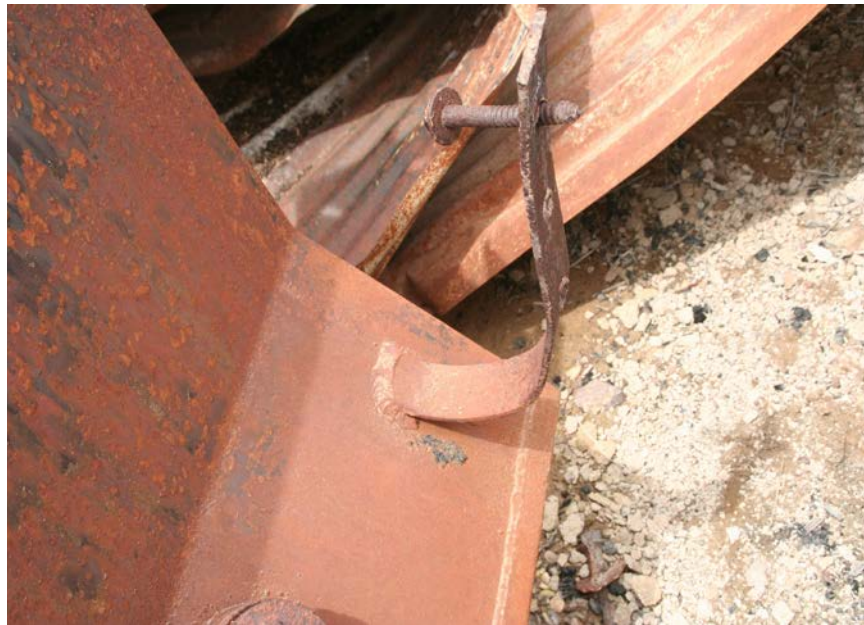
Figure 12. One remaining strap.

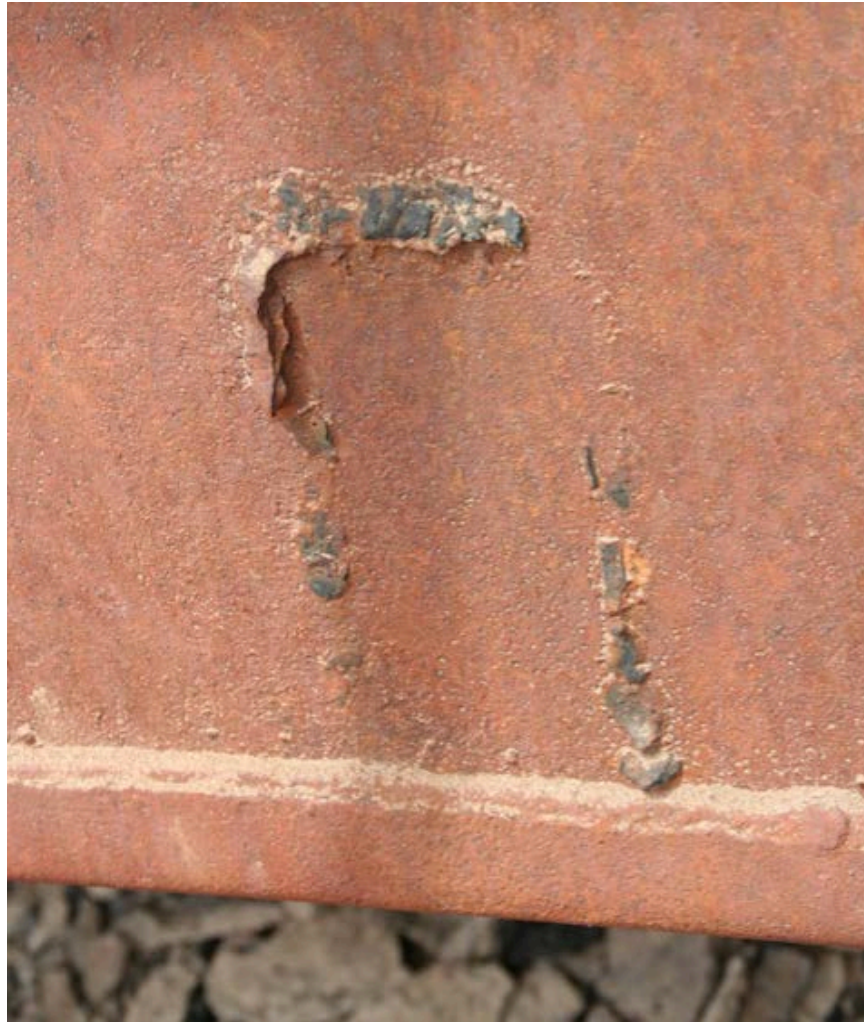
Figure 13. Attachment point of middle strap. The weld broke during the dislocation event.

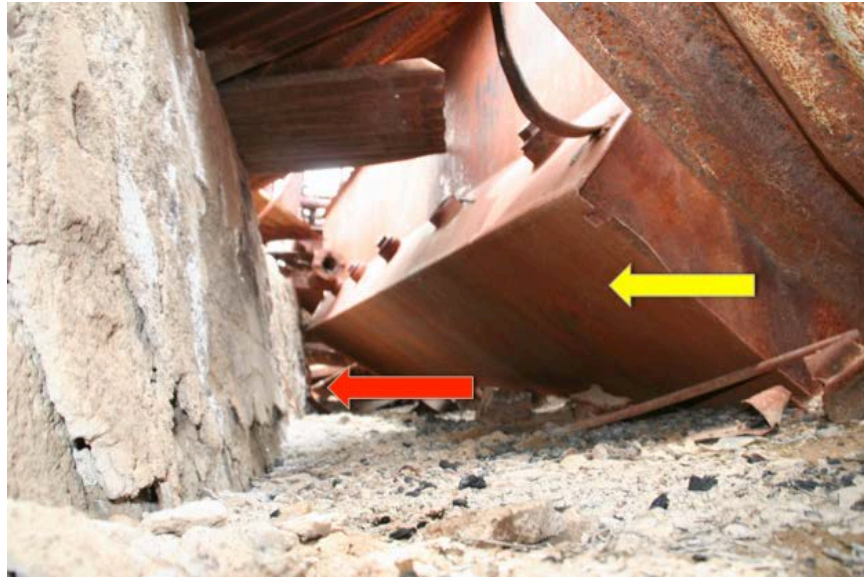
Evidence indicates that the flotation machine was probably pushed or heaved off of the elevated concrete terrace that it was normally mounted on. My estimation of the weight of this machine is approximately 3,000-4,000 pounds.

Figure 15. Flotation machine resting on floor below its normal terrace perch. Red arrow indicates 3' high flotation machine terrace wall. Yellow arrow indicates bottom of the flotation machine.

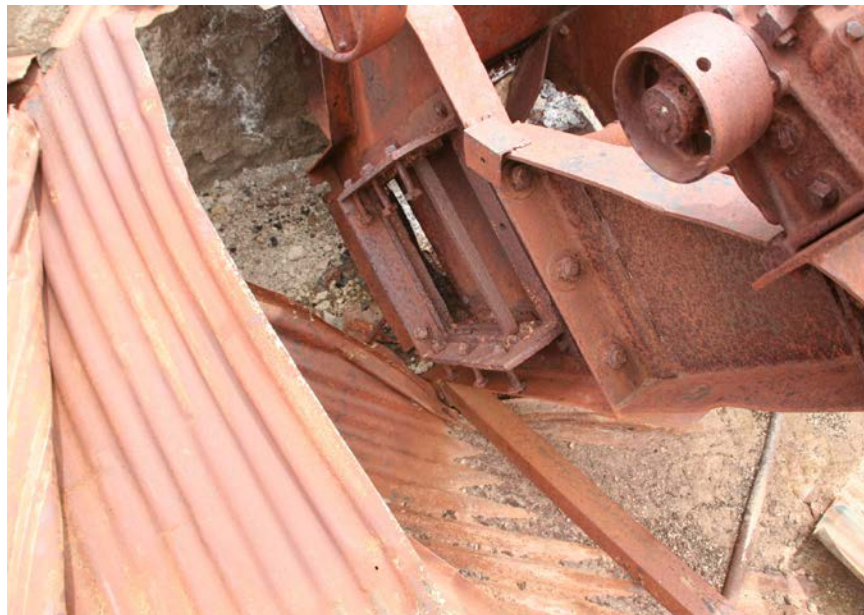
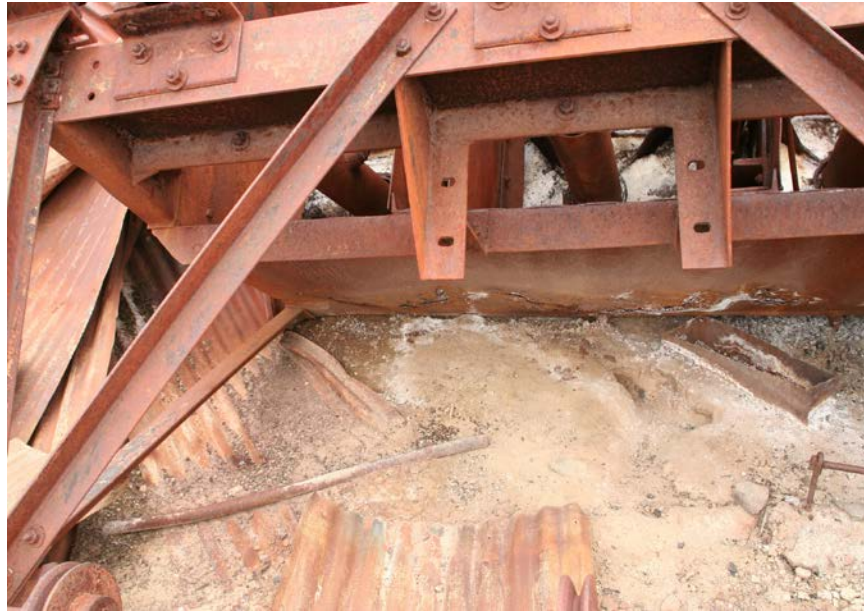
Further support of this theory is the nature of some of the roof/wall panels in relation to the flotation machine. An examination of the flotation machine's final resting spot reveals the presence of roof/wall panels underneath the flotation machine. The flotation machine is resting on several roof-wall panels. Figure 16-17.

Figure 16. Roof/wall panel sandwiched underneath flotation machine. View 1.

Figure 17. Roof/wall panel sandwiched underneath flotation machine. View2.

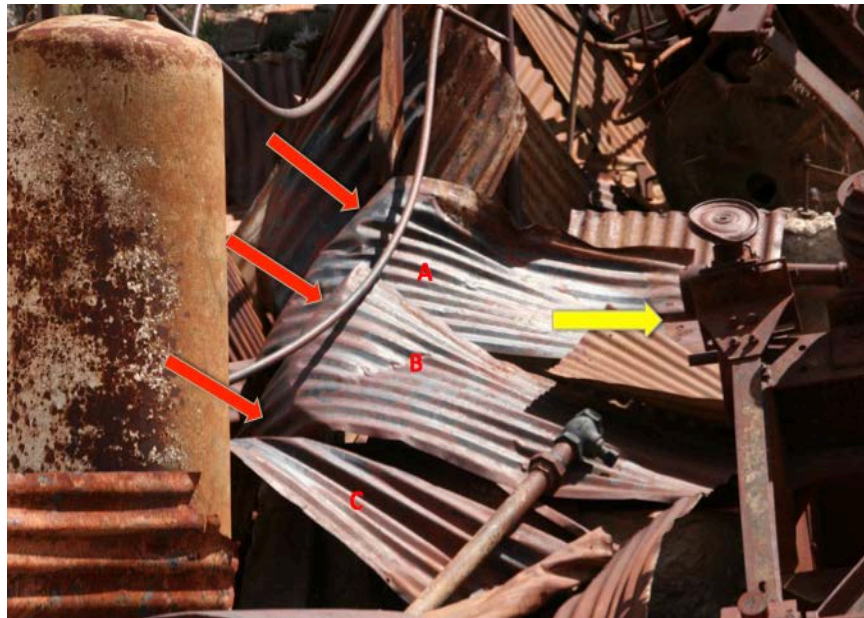
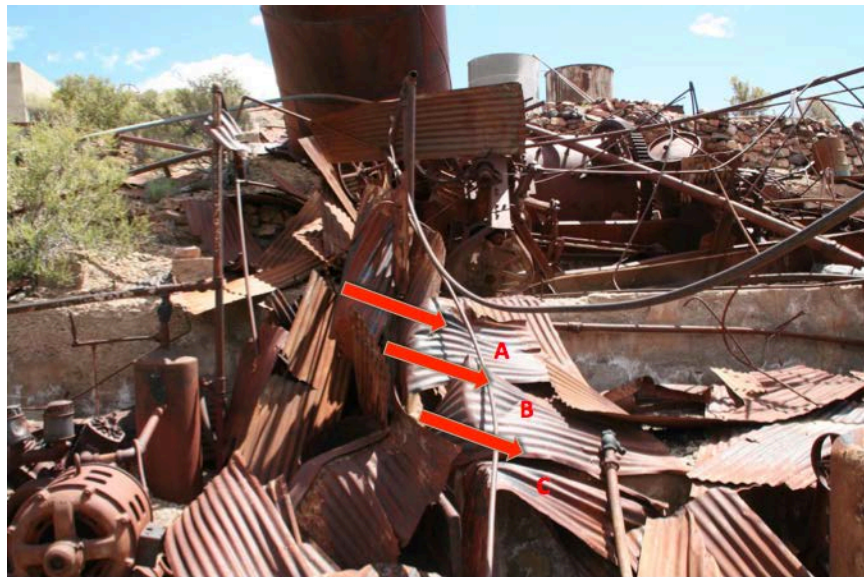
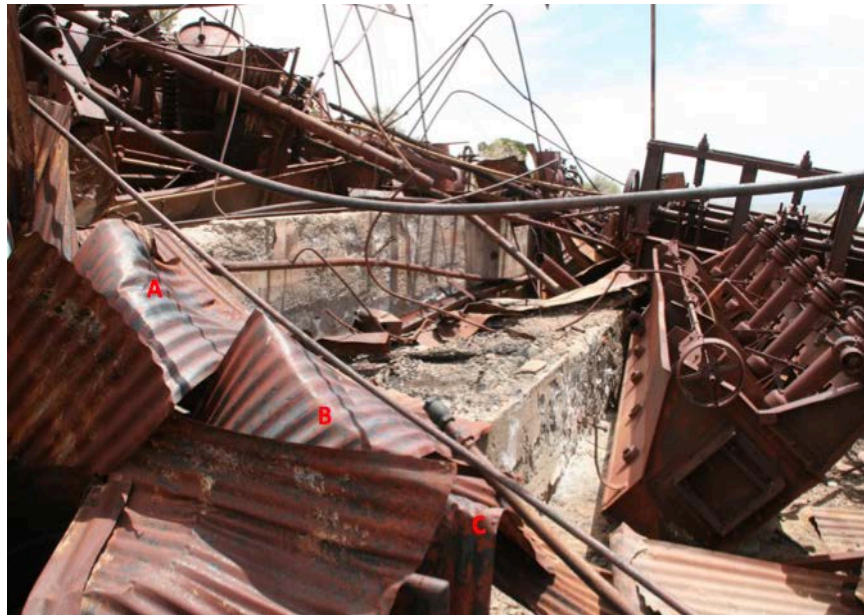
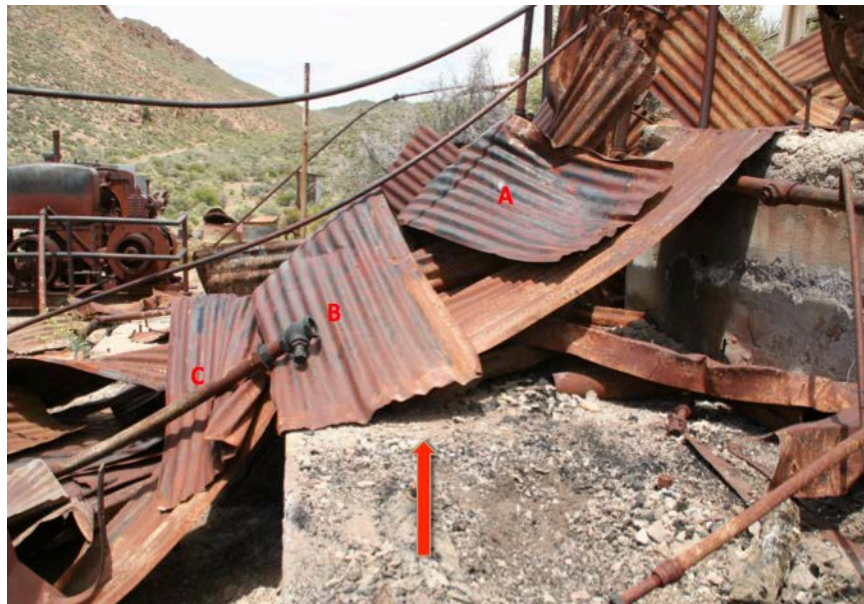
An examination of the entire Mill Building structure revealed that one area and one area only exhibited a particular effect on roof/wall panels. Immediately adjacent to the 6-cell flotation machine terrace on the north side of same area are three roof/wall panels that exhibit a distinct and consistent bend pattern from outside the mill room to inside the mill room. The bends in these panels are greater than 90 degrees from vertical and are graduating from high to low. The high end, or easterly most panel (Panel A) is bent at a higher point than the center panel (Panel B). The center roof/wall panel (Panel B) is bent at a higher point than the bottom panel (Panel C). Figure 18-21.

Figure 18. Yellow arrow is the 6-cell flotation machine.

Figure 19. View looking east.

Figure 20. View looking south and east.

Figure 21. Red arrow indicates generally north.

The above photographic evidence supports the theory that some large, heavy, airborne item may have impacted the Mill Building at this point. The shape of which, the configuration, the velocity, and the purpose all are unknown to this analyst.

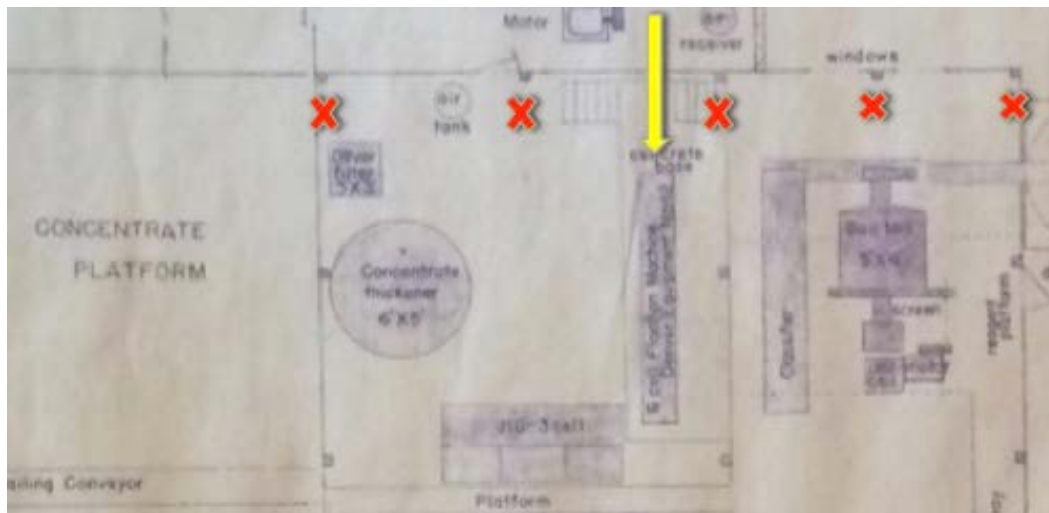
When combined with evidence that the flotation machine was probably pushed or heaved from its normal position on the terrace in a westerly direction and the point of impact as determined by the location of Panels A, B, and C; it is reasonable to believe that whatever impacted the Mill Building at the point identified may have been responsible for the immediate dislocation of the flotation machine to the floor. In addition, a heavy item impacting the Mill Building at the point indicated may have been causal to the early “leaning” and collapse of the building as a result of impact destruction of the vertical structural members in the area of the north end of the flotation machine terrace. Figure 22.

Figure 22. Red X's represent 6x6 vertical structural members, which support the walls. Yellow X represents the suspected path of the impact device or object. It is possible that an impact at this location could have destroyed or severely compromised the vertical structural members promoting early structural failure on the north end of the Mill Building, which could cause the building to lean to the north early in the event as described by Dan Sheahan.

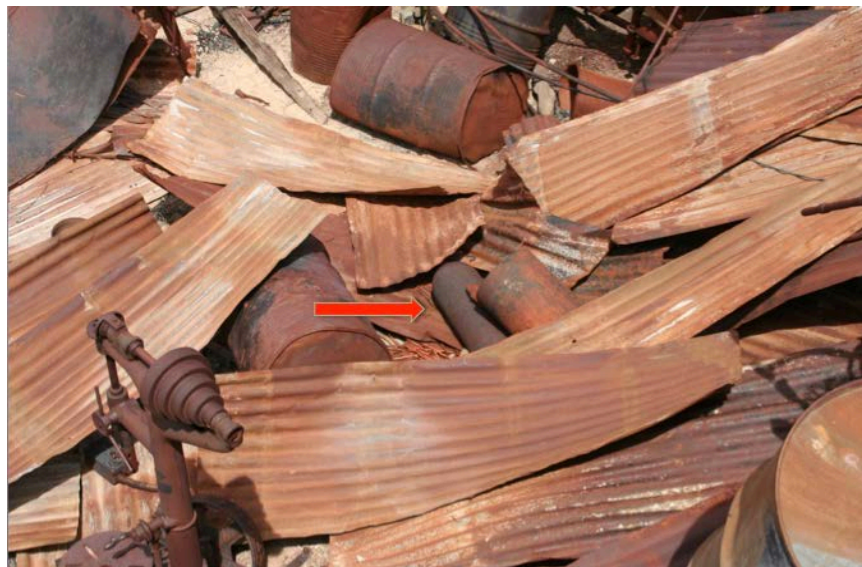
Figure 23. Oxy-Acetylene kit tanks located in the upper tier Shop area; photographed as found.

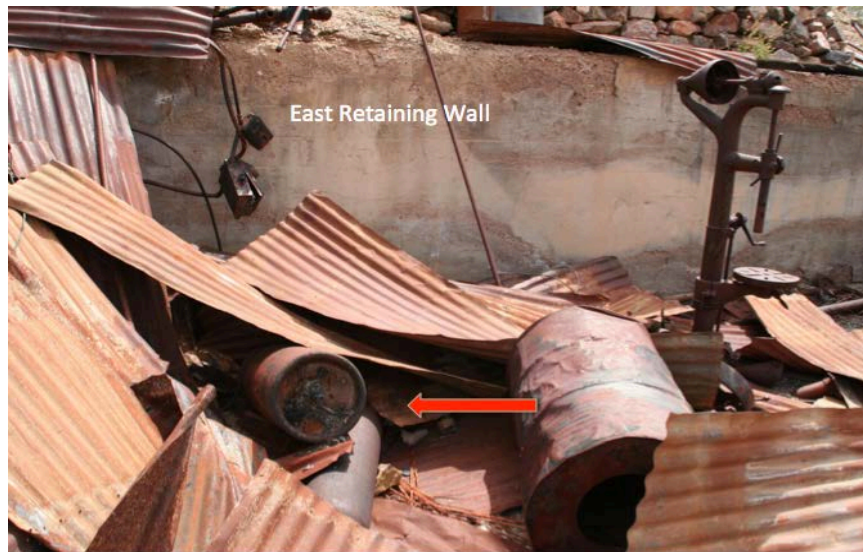
Figure 24. Oxy-acetylene tanks.

As the tanks lie I noticed only slight bulging to the acetylene tank on the south side of that tank, or the photographer's right in Figure 24. On closer examination I located three separate rupture points on the acetylene tank. Two are displayed in Figure 25. The third rupture is displayed in Figure 26. There was no evidence of rupture on the oxygen tank. Because of the bulging of the acetylene tank at the rupture points, it is evident that the tank failed due to a B.L.E.V.E. or Boiling Liquid Expanding Vapor Explosion (See def. 23.2.2.1 B.L.E.V.E).

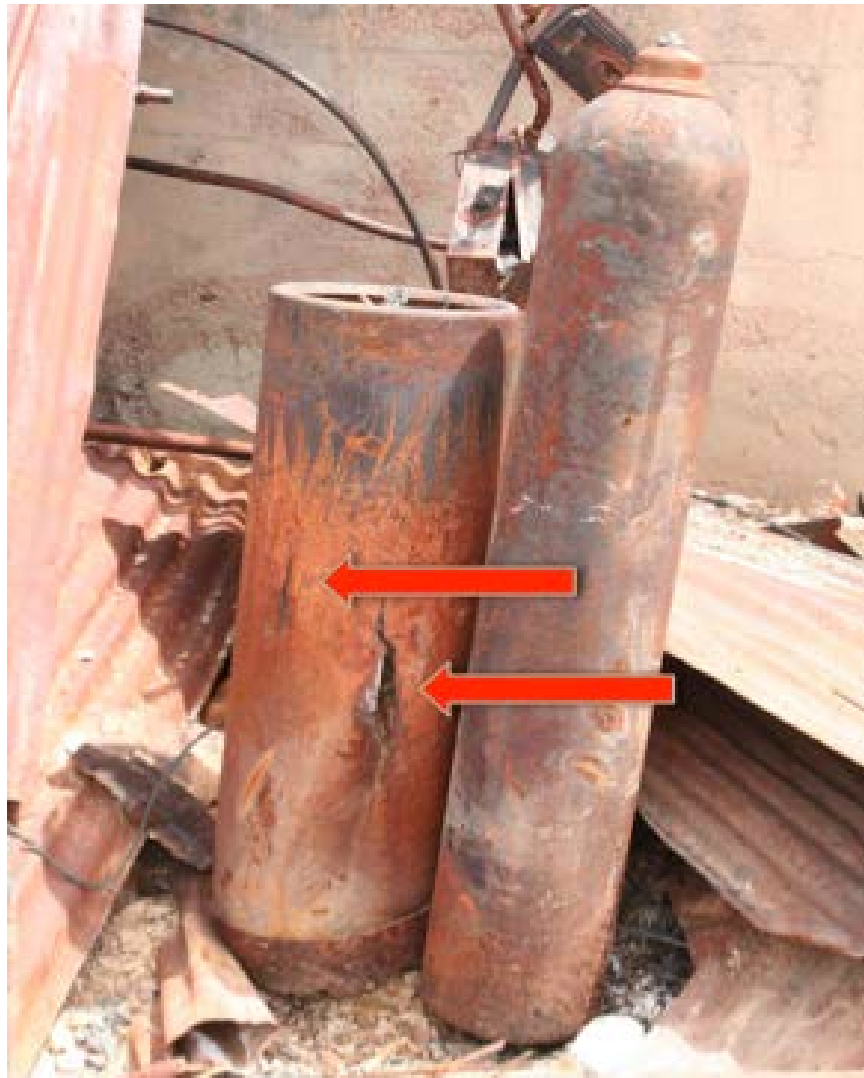
Figure 25. Acetylene tank rupture points.

Evidence revealed by the post-fire condition of the acetylene tank indicates that there were three separate rupture points on the tank, which indicates the entire tank was exposed to fire for a prolonged period of time causing a catastrophic rupture of the tank in three different areas. This rules out a localized torch flame impinging on the acetylene tanks as cause of the rupture. Such a fire causing a B.L.E.V.E. of the acetylene tank was not the result of the acetylene tank rupture but rather the acetylene tank rupture was the result of a fire burning in the Mill Building resulting from an explosion and instant fire, which occurred according to the Sheahan's.

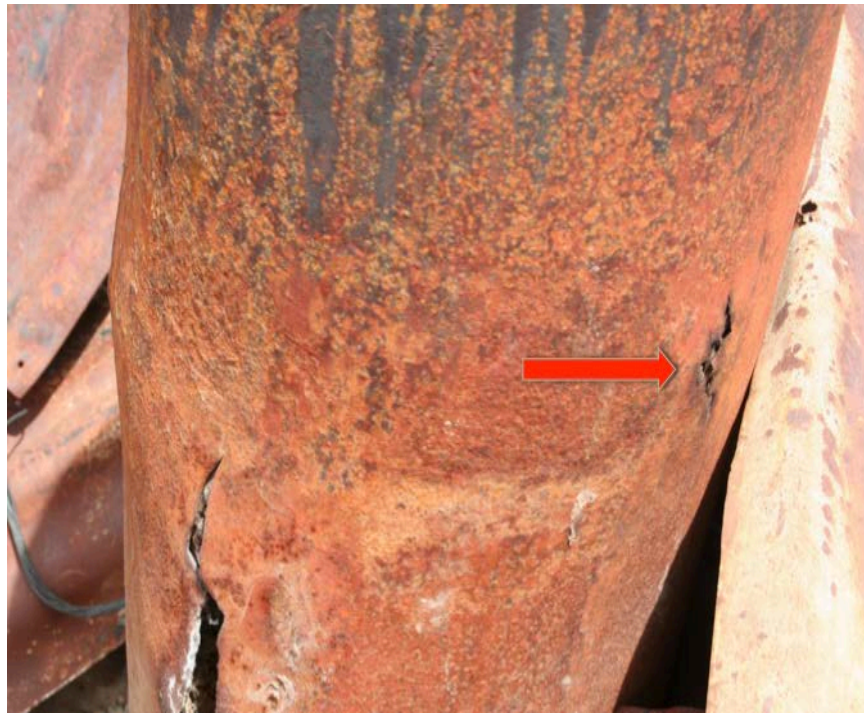
Figure 26. Third acetylene tank rupture point.

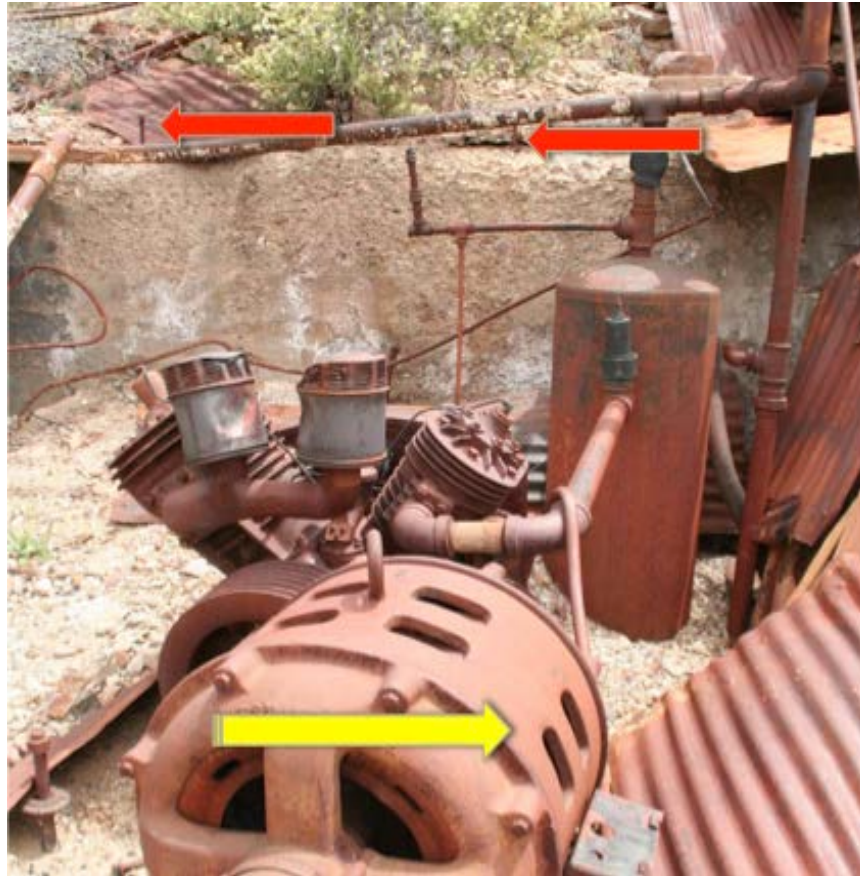
Available fire patterns indicate a greater level of destruction by fire near the flotation machine terrace and engine room than to the remainder of the building. Figures 27-29 reveal the location of the bottom heavy timber frame base plates of the structural frame of the Mill Building. These pieces of lumber likely had the same 6"x6" dimensions as the vertical support posts. These base plates were completely or almost completely consumed by fire at this point.

Figure 27. Red arrows indicate lag bolts used to secure heavy timber frame base plates to the retaining wall. The yellow arrow points south.

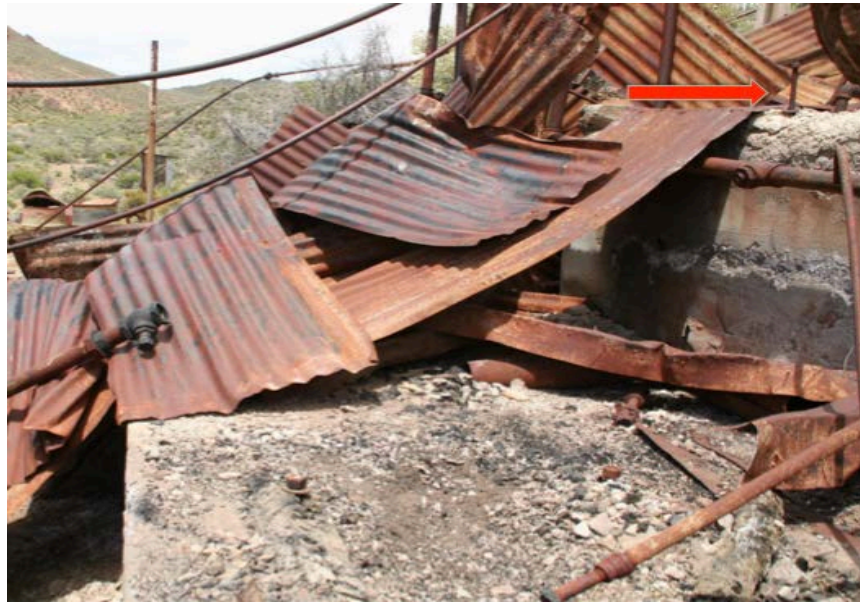
Figure 28. Red arrow indicates one lag bolt used to secure frame base plates to the retaining wall. Base plate is completely consumed by fire.

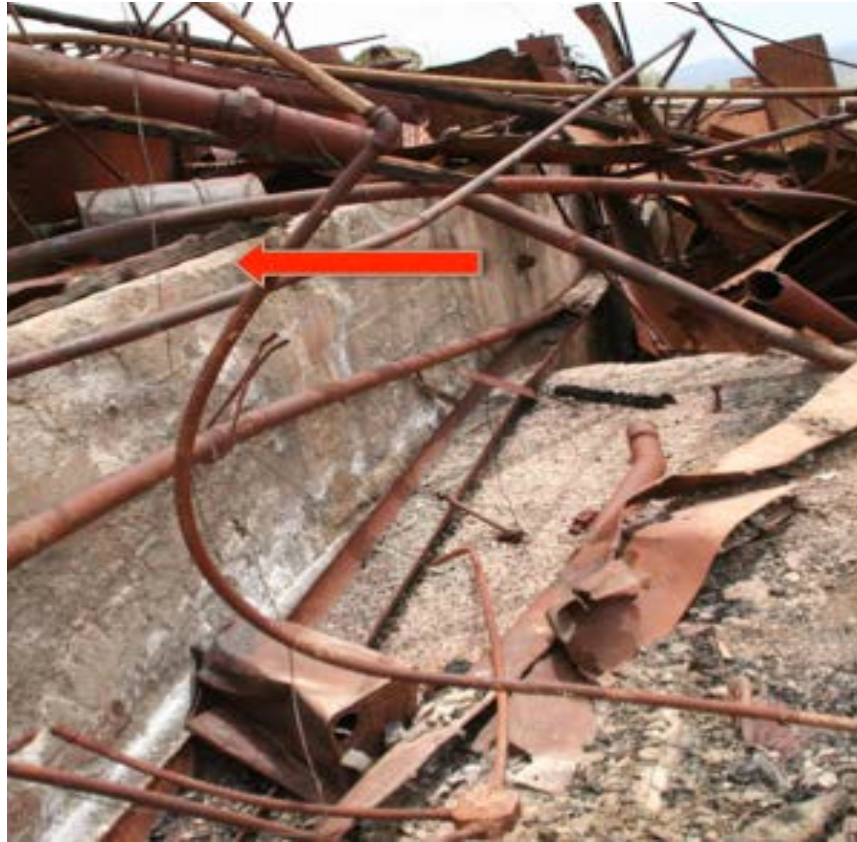
Figure 29. Small piece of frame base plate remaining on retaining wall bordering flotation machine terrace. Mass loss due to exposure to fire is greater nearer the point of entry of suspected impact object.

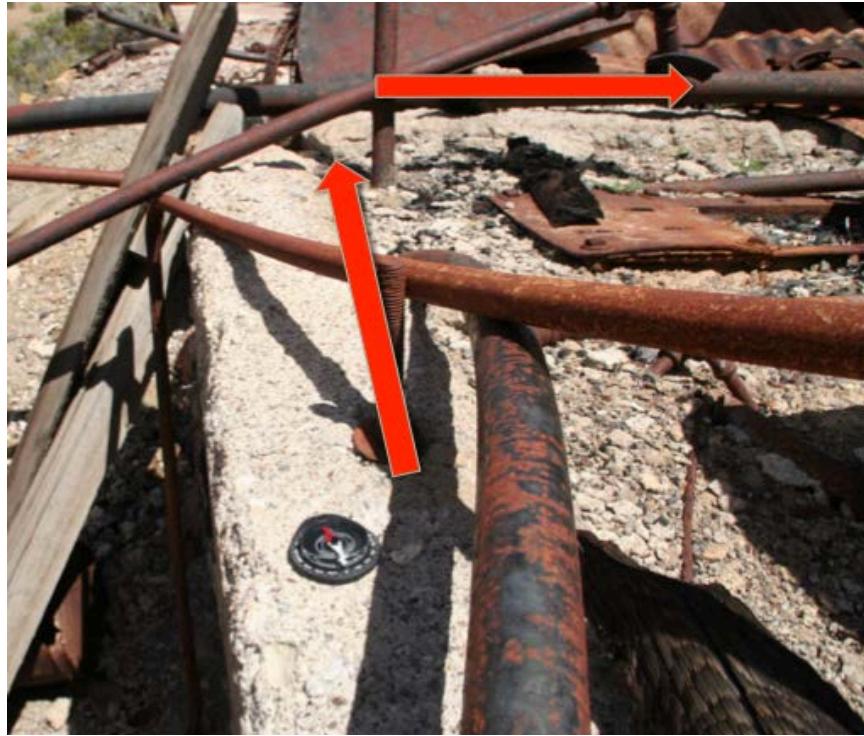
Figure 30 below depicts the northwest corner of the milling floor or bottom tier of the Milling Building. This photograph demonstrates the level of destruction to the frame base plates. The base plates were completely consumed by fire.

Figure 30. Northwest corner of the Mill Building lower tier wall. No remaining base plates due to consumption by fire.

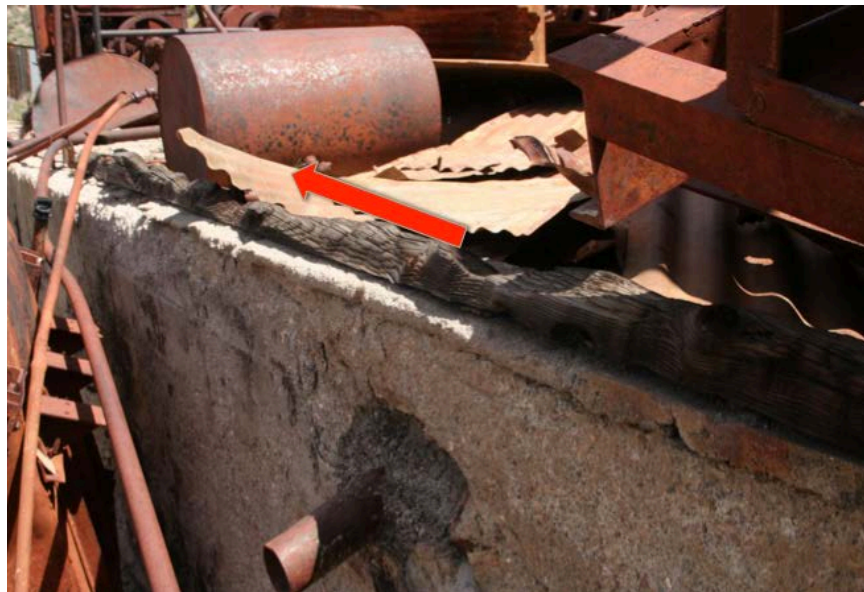
As the distance from the north end of the flotation machine terrace (identified probable impact point) increases, fire damage to remaining wooden structural members decreases indicating a reduced exposure to fire in terms of fire burn time, fire intensity, or both (Figure 31-33).

Figure 31. Red arrow points north and indicates increasing destruction to frame base plate from south to north indicating greater exposure to fire on the northerly side (northwest corner of machine room, lower tier of Mill Building).

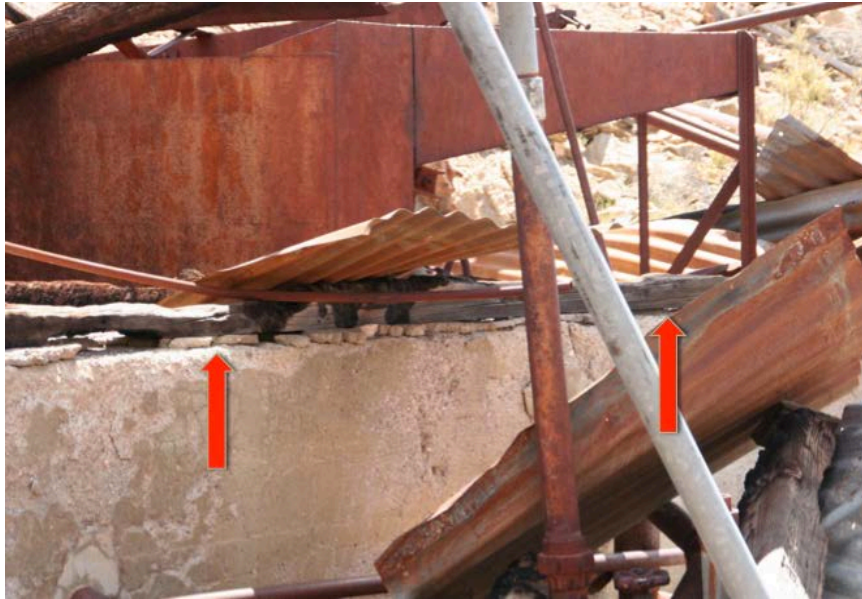
Figure 32. The remains of the frame base plate near the southwest corner of the Mill Building. This location is essentially diagonal from the flotation machine terrace and identified impact point. This photo demonstrates a reduced level of damage to construction members indicating it is away from the area of origin.

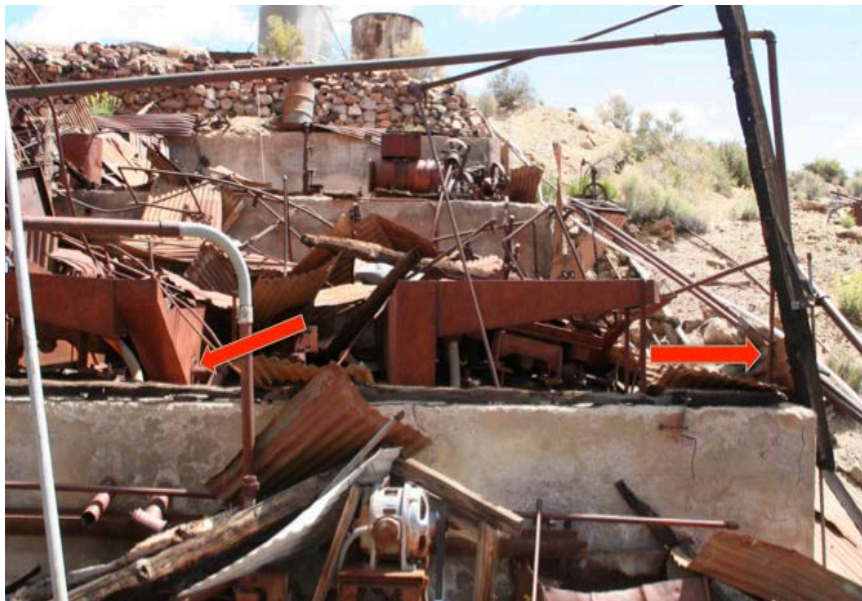
Figure 33. Demonstrates the southwest corner of the Mill Building. Construction members suffered less exposure to fire away from the flotation machine terrace and identified impact point.
